**NOISE LAB**  
**REPORT Number A-2021LAB-003-I897-44249\_E**

**Customer :** CENTEXBEL  
 Technologiepark 70  
 9052 Zwijnaarde  
 Belgium

**Tests :** Laboratory measurement of the reduction of impact noise by a floating floor system  
 on a heavyweight standard floor.  
**Product name :** Rubber tiles T2102136

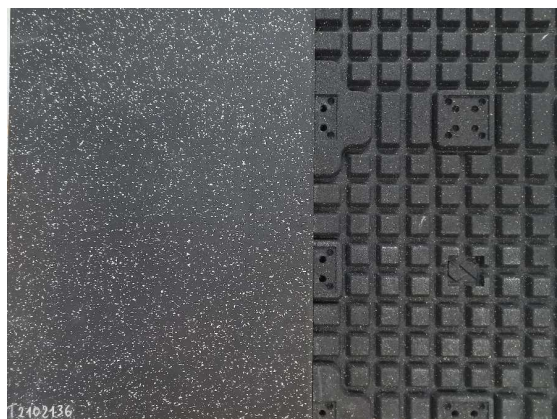
the top side completely flat and a waffled pattern on the base  
 thickness : 27 mm (as verified on the samples)  
 dimensions : 500mmx1000mm  
 weight : 11,0kg ( verified on one sample)

photo : top side and structured bottom side of the rubber tile

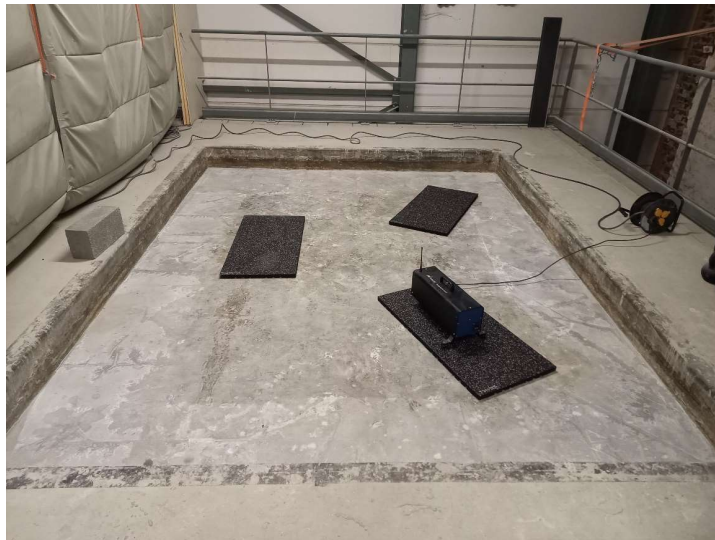
The rubber tiles were classified as a 'category I' material, as mentioned in part H2.2.1 of the standard ISO10140-1.  
This category includes flexible coverings.  
Three little samples large enough to support the whole tapping machine were loosely laid on the concrete reference floor.

*photo : total test setup*

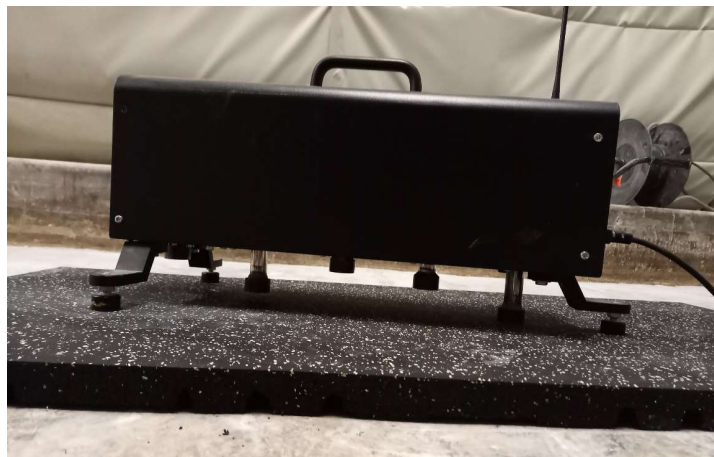
*photo: detail with the tapping machine on one rubber tile*
